## **Role of Construction in the Poor Performance of Deck Panel Bridges**

### **Abstract**

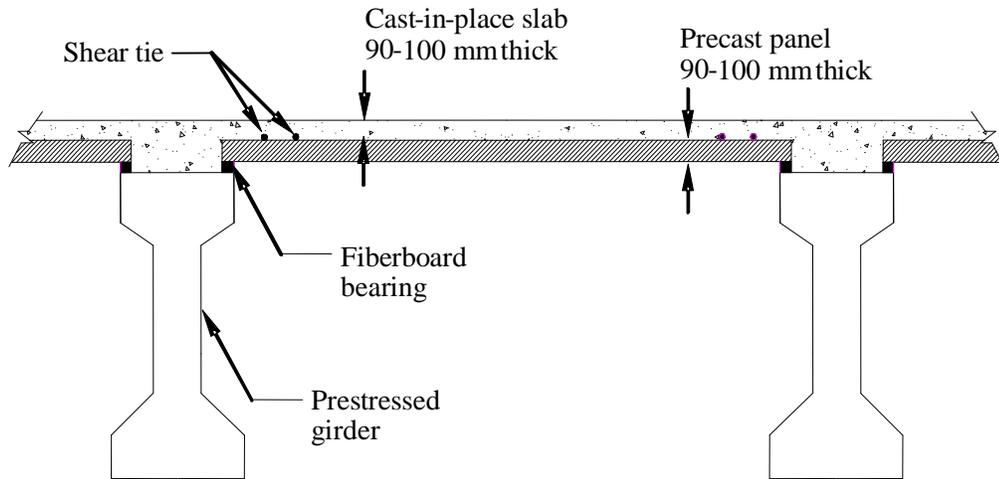
**Figure 1: Cross Section of Precast Prestressed Panel Deck**

In 1982, Florida Department of Transportation asked the University of Florida, Department of Civil Engineering, to perform an in-depth study as to why the decks were prematurely cracking along the beams. The report (Structures and Materials Research Report No. 85-1 by Hays and Tabatabai, August 1985) concluded that the primary problem with the design was the placement of the panels onto the adjacent girders supported only by fiberboard bearing material (see Fig. 1), instead of using a solid, positive bearing material.

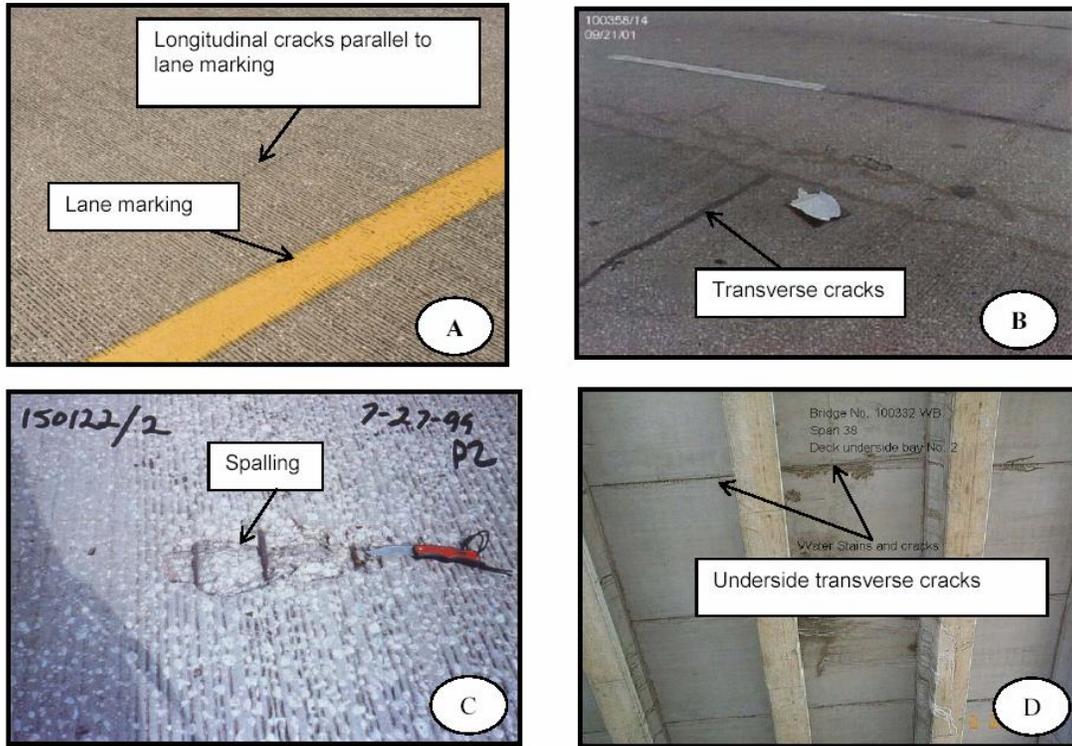
Under federal law, all bridges are required to be inspected once every two years. During routine inspection even in newly constructed bridges, deficiencies in the form of cracking and spalling were detected. The first sign of deficiency usually appeared in the form of a crack on the deck top surface that can be parallel (Fig. 2A) or perpendicular (Fig. 2B) to the traffic direction reflecting the longitudinal and transverse panel edges. Spalls subsequently develop (Fig. 2C). Cracking can also occur on the deck underside. Underside transverse cracks (Fig. 2D) generally appear in the center and on the ends of the panels and radial cracks appear on the edges. Underside cracking is more hazardous, because unlike the visible deck top cracks, decks are rarely viewed from the bottom unless a formal inspection is being conducted.

**Figure 2: Cracking in Deck Panel Bridges**

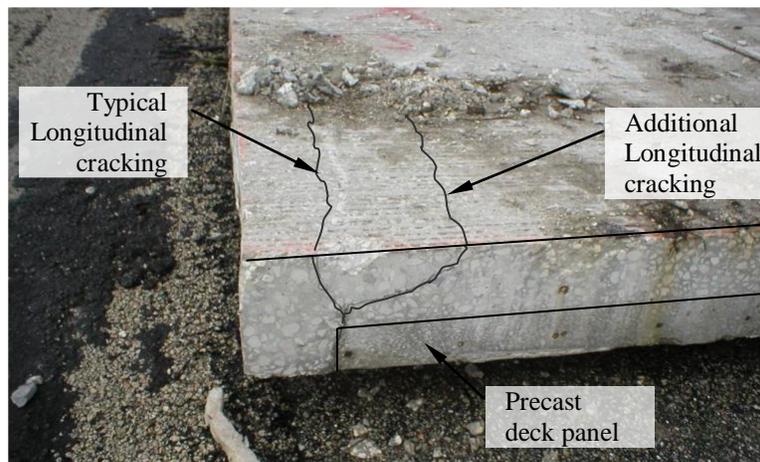
**Figure 3: View of Cracking in Retrieved Panel**

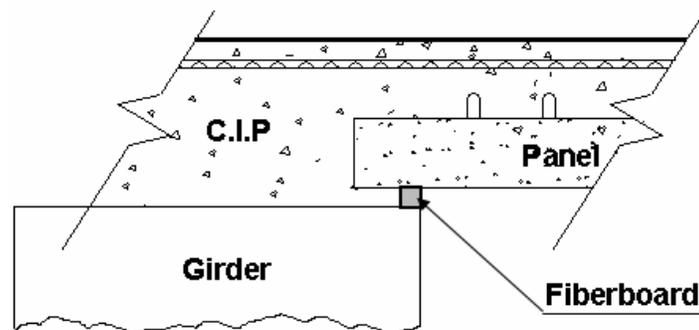
Despite these limitations, sufficient information was obtained to allow the development of a progressive deterioration model. Additionally it also permitted actual support conditions for deck panels to be examined. This showed that contrary to widely held views that all deck panel bridges in Florida were supported on fiberboard panels, bridges that performed well had been constructed differently. In these bridges, the deck was supported on a 25 mm to 40 mm mortar bed (Fig. 4). This permitted wheel loads to be transferred by the entire slab not just the precast panel.

**Figure 4: Correctly Constructed Deck Panel Bridge Deck**

While the performance of deck panel bridges with mortar support (Fig. 4) was better than those with only fiberboard support (Fig. 1), they also displayed longitudinal cracking on the deck. However, these cracks did not further develop into spalls. In isolated cases, deck panel bridges with mortar support also developed serious spalls. Forensic study of these regions revealed that this was a result of poor construction which resulted in inadequate mortar support under the panel, resulting in the panel being supported mainly on the fiberboard (similar to Fig 1). This was caused due insufficient overhang of the panel from the fiberboard, and also due to incomplete flow of mortar under the panel. Recent design standards for deck panel construction (Merrill, 2002) address this by specifying a minimum of 38 mm overhang of the panel from the fiberboard and a minimum 6.25 mm thick gap between the girder and the panel to enable adequate flow of mortar under the panel (Fig. 6).

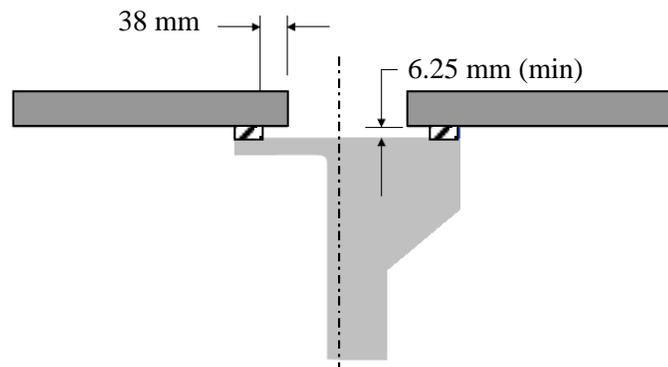
**Figure 6: Texas DOT Standards for Deck Panel Bridge Construction (Merrill, 2002)**
