Second International Conference on Construction in the 21st Century (CITC-II) "Sustainability and Innovation in Management and Technology" 10-12 December, 2003, Hong Kong

Lessons Learned in the Design and Construction of a Wastewater Earth Liner Project

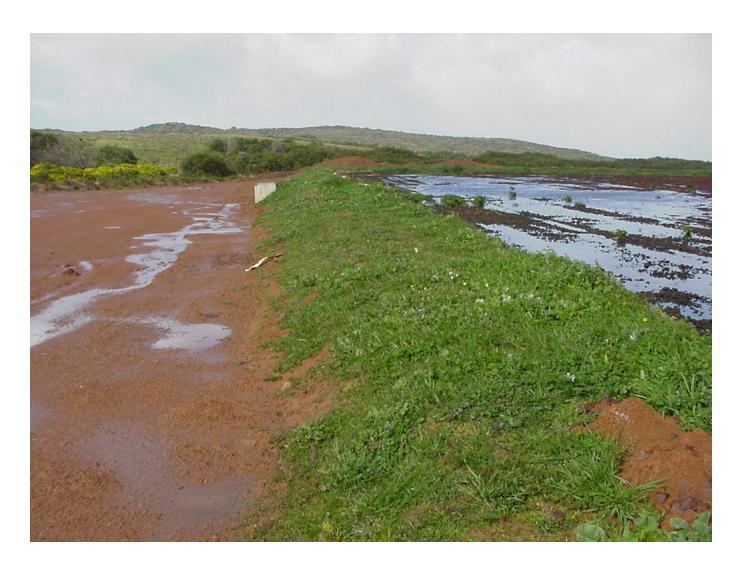
The project was executed under a traditional construction contract involving a client (a regional water authority), a designer/superintendent (a geotechnical consulting engineer) and the constructor (an earthwork contractor). The project comprised a series of shallow earth-lined reed beds to allow biological secondary treatment of sewage effluent. Only days after commissioning of the reed beds, many of the reed beds failed functionally with significant effluent leakage. Plate 1 shows a typical reed bed and associated leakage.

Plate 1: Typical Reed Bed and Leakage

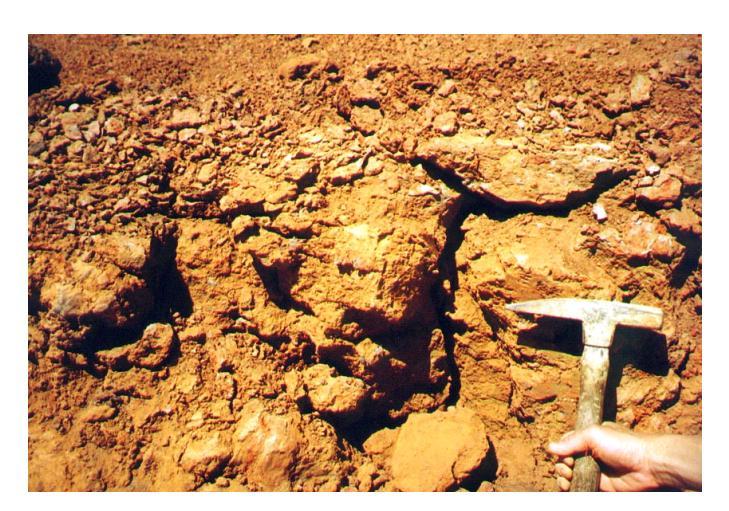
Extensive shrinkage cracks (some propagating more than 300mm into earth mass) were common in the exposed earth mass of the failed reed beds (see Plate 2).

Plate 2: Desiccation of Clay Liner Caused by Excessive Drying

Given the high shrinkage potential of the imported clay there was no doubt that any exposed earthwork of the reed beds needed to be protected from drying as soon as it was completed. Unfortunately the original reed beds were exposed to weather without any surface protection for a prolonged period – a duration of about six months between earthwork completion and commissioning of reed beds (refer to Table 1). In addition to this, topsoiling of the reed beds was not included as part of the original earthwork contract and was not applied long after all earthwork was completed.

In summary, the desiccation cracking of the original reed beds was intensified due to a combination of: a lack of post-practical completion maintenance or permanent surface protection to prevent excessive drying; delay in commissioning of the reed beds which provided a six-months drying time to the reed beds (otherwise at least the upstream face would have been protected by the wetting of effluent even without surface protection); and an undesirable high void content in some local inadequately compacted clay.
