## **Insights about Concrete Spalling in a South African Region**

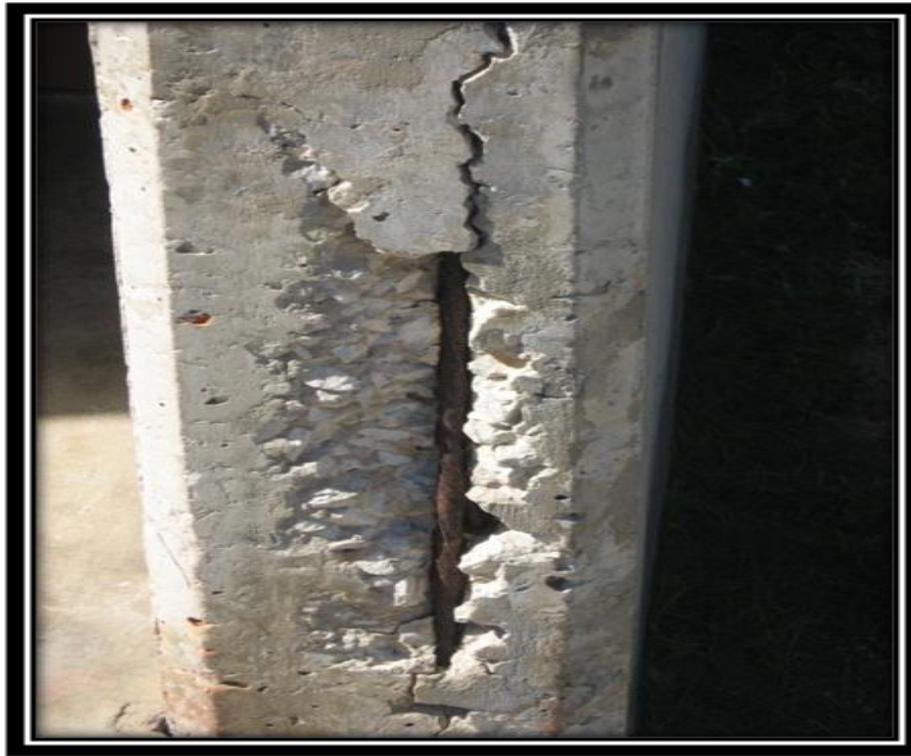
**Figure 1: Spalling due to expansive forces of corroding reinforcement (Photo: H.J Duminy)**

'Reinforcement is the Achilles heel of concrete' as the one is dependent on the other as steel plays an integral part in the resistance of tensile stresses accumulated in concrete members (Day, 2006). It is known that reinforcement corrosion in reinforced concrete structures is the main factor contributing to the reduced service life of reinforced concrete structures (Batis *et al.*, 2004) as spalling occurs due to the expansive forces (see Figure 1 for an example) that are being exerted within the concrete as a result of the corroding reinforcement (Li *et al.*, 2005). These corroding reinforcements then wedges out concrete (Day, 2006). Cracks give access to more moisture and aggressive agents, which catalyze the whole deterioration process (Muigai, 2008). Thus to protect the reinforcement embedded within the concrete, one has to design the desired quality and concrete cover thickness taking into consideration the environment in which the concrete member will find itself (Muigai, 2008). Cover of concrete is very much prone to be neglected due to improper curing and compaction techniques and this could lead to the penetration of undesired moisture and other 'aggressive agents' (Muigai, 2008).
