## **Excavation of Ankara Metro Shaft by Using Inclined Piles**

Orhan Barut

*GÜRİŞ İnşaat ve Mühendislik A.Ş., Ankara, Turkey  
obarut@guris.com.tr*

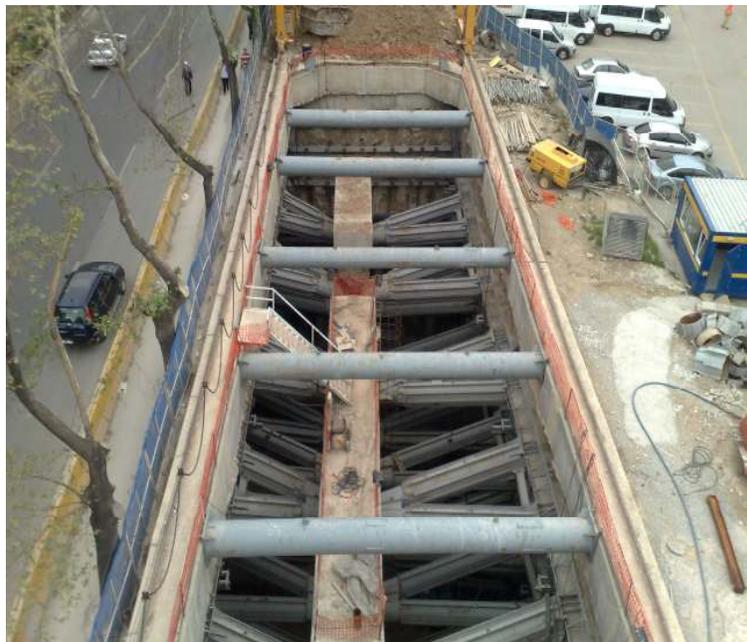
Excavation was completed at 5 stages as parallel to the supporting steel beams levels.

**Figure 3: Excavation Area at Ground Level**

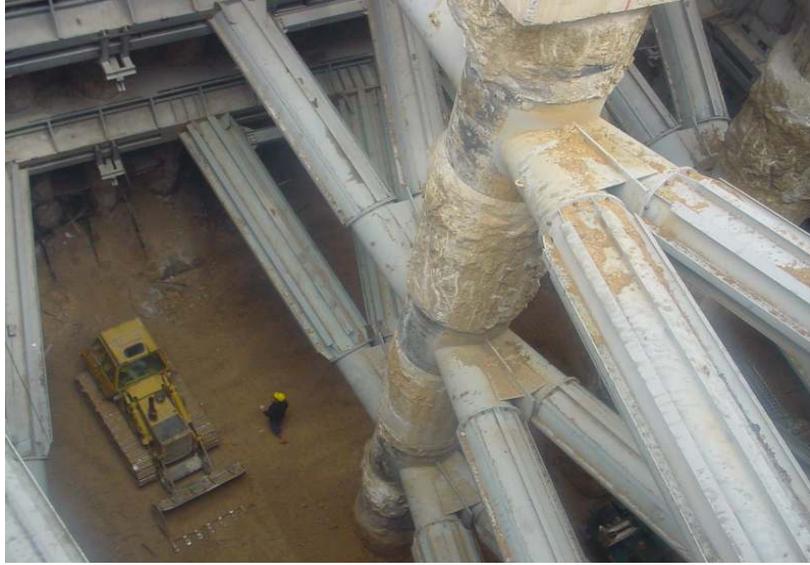
**Figure 4: Support Beams at Intermediate Levels**

Critical points of the steel beams carrying maximum loads were determined and strain gages were installed at those points. During all the excavation period, the loads measured by the gages were compared with the theoretical values given by the calculations by using a software on 24 hours real-time basis.

All the loads measured by strain gages were in compliance with the theoretical calculations. They were never reached more than 90% of theoretical values.

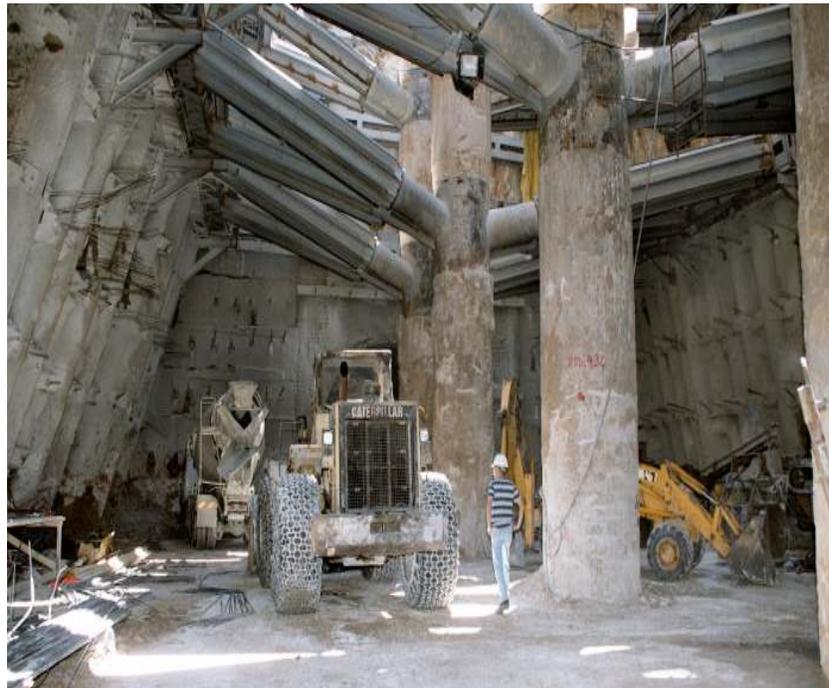
**Figure 5: Excavation at Bottom Level**

Excavation was completed without any problem. Neither damage nor disturbance were given to the surroundings. Traffic was not effected by the construction.

The most critical factor of piling was the linearity tolerance of the inclined piles. If the deviation becomes more than tolared there may be a risk of water leakage problem. At the end of excavation it was detected that deviations were within expected limits and no water leakage problem happened.
