Condition Assessment of Building Thermal Leakage Using Infrared Thermal Imaging: A Case Study of a University in the UAE

CITC- 15 | November 10 - 14, 2025
Hosted by The International University of Rabat
Rabat, Morocco

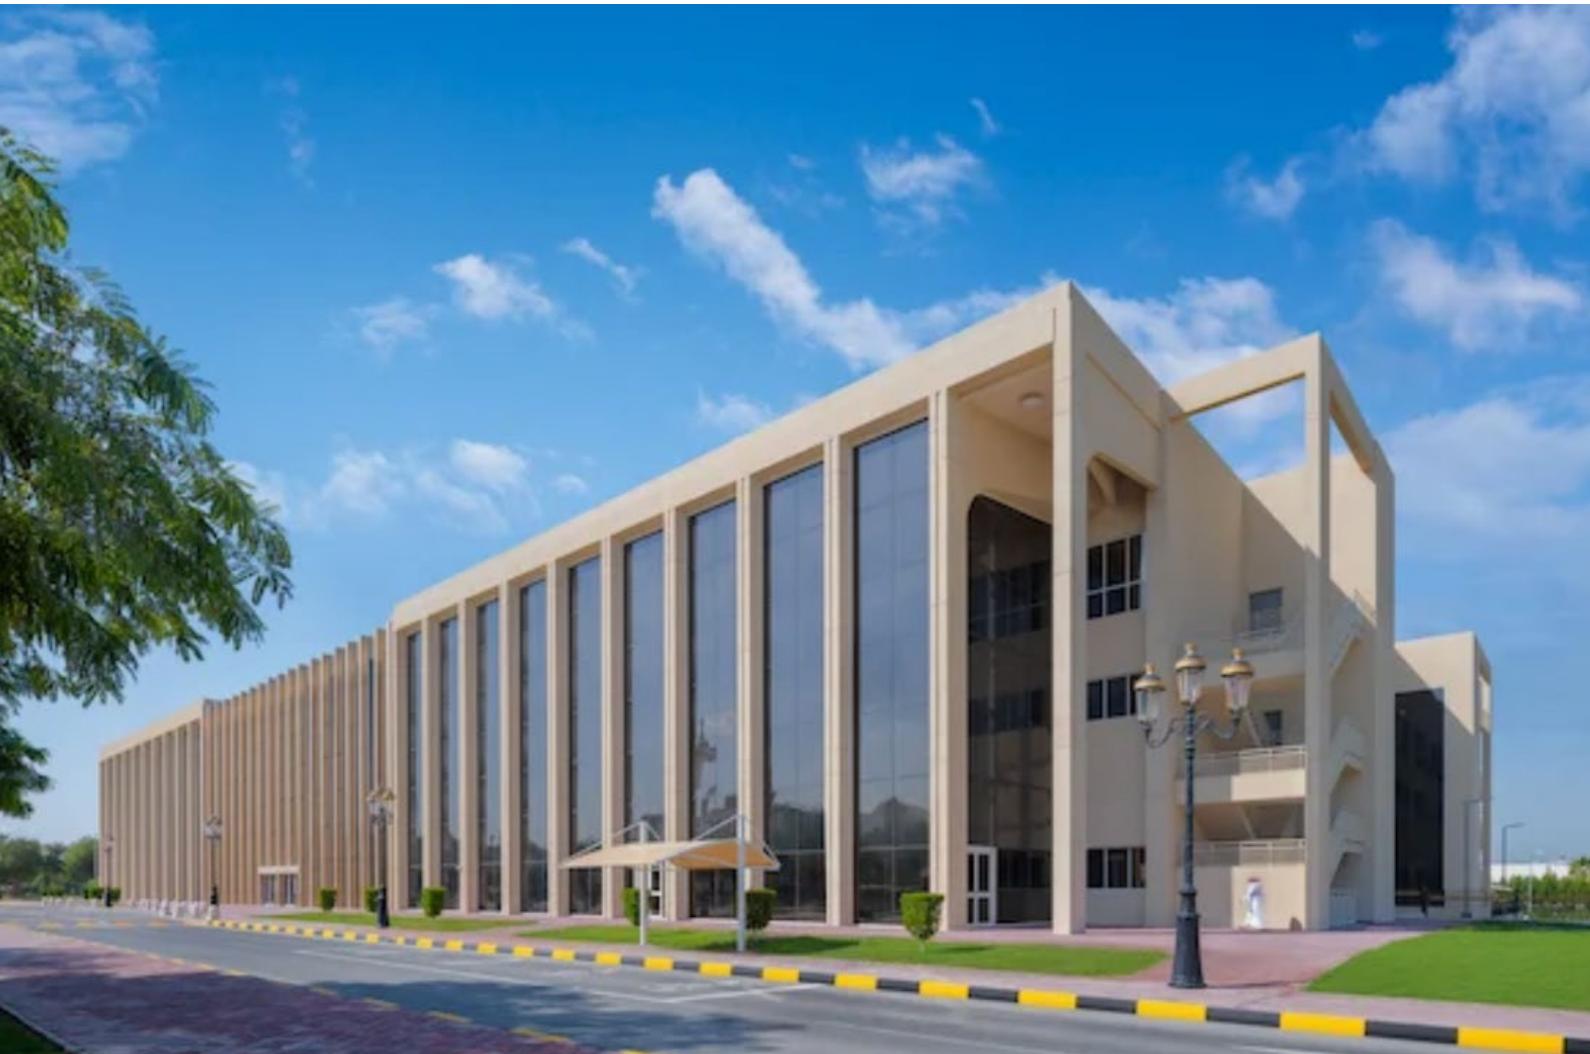
ESB (Engineering & Science Building): Newly constructed, high-performance envelope

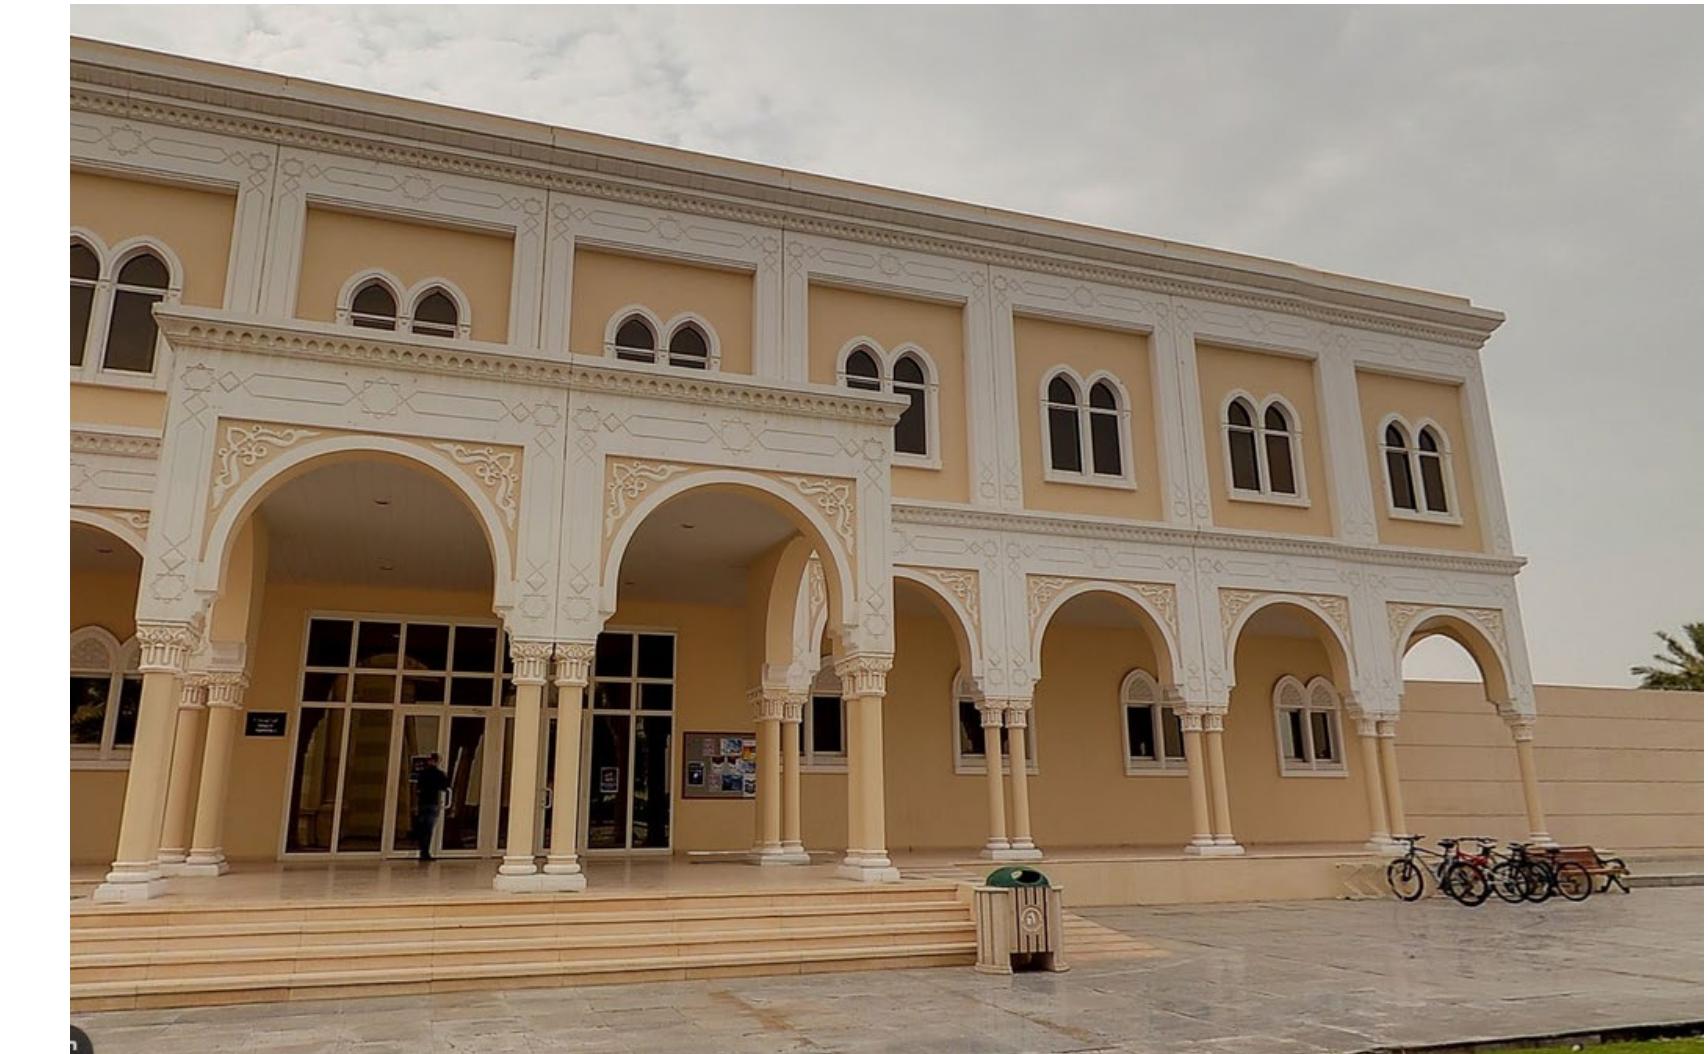
EB2 (Engineering Building 2): Older construction, likely more leakage

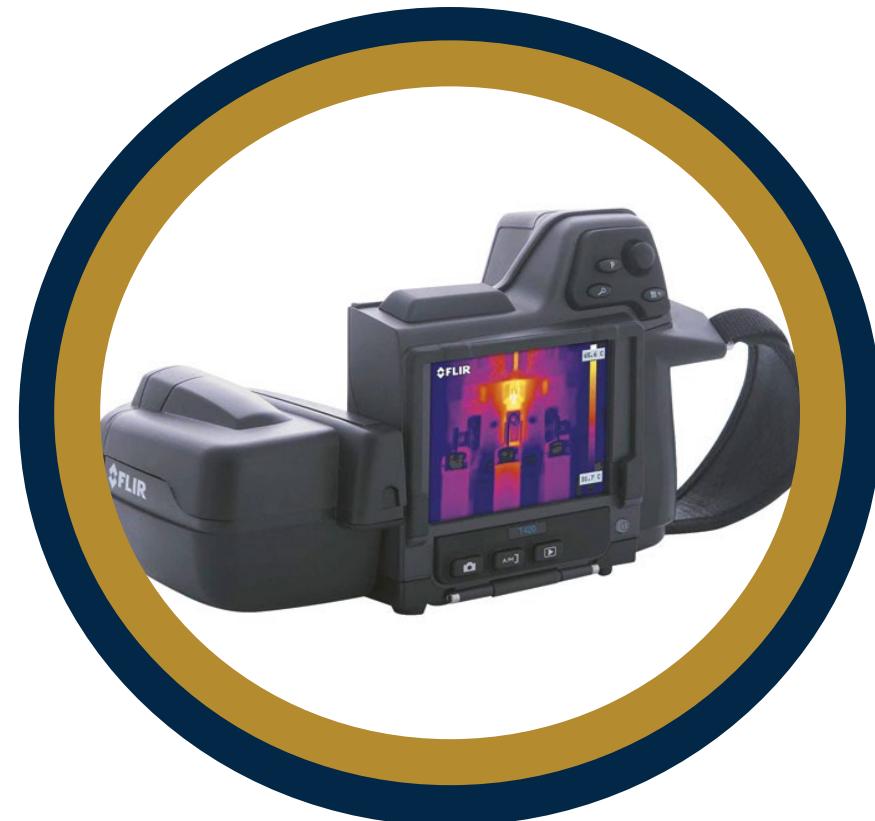
Figure 1 : IR thermal camera used for the assessment (FLIR -T62101).

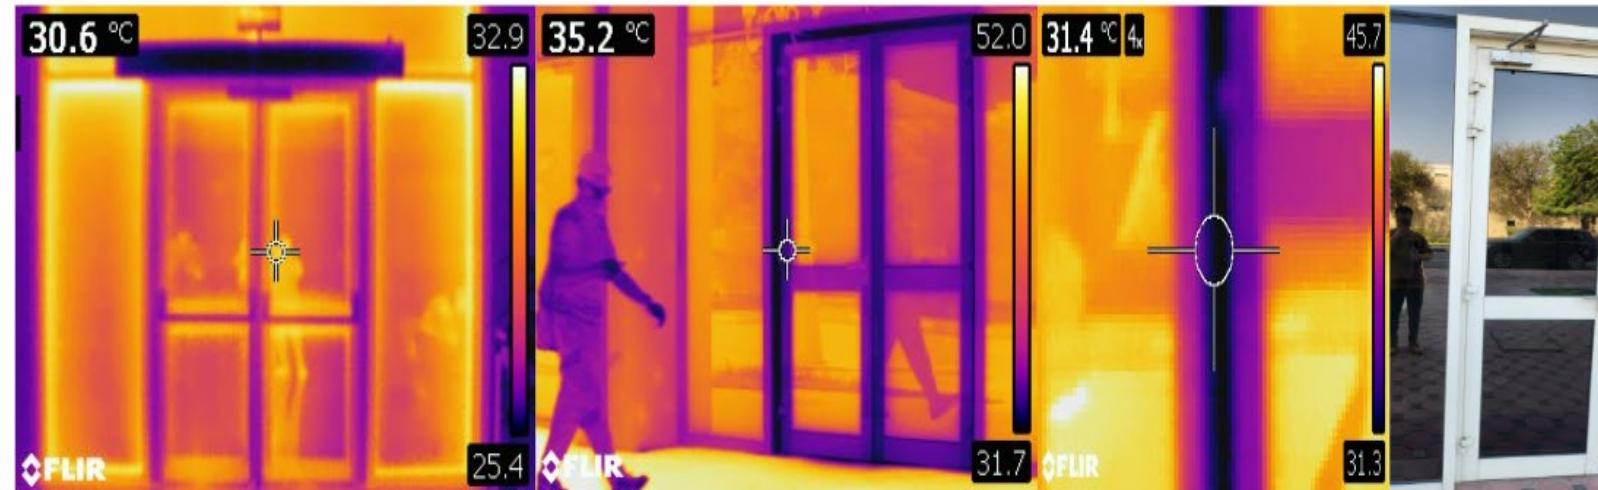
Emergency Exit Doors

Figure 3 : IR and normal images capturing the emergency exit doors of ESB building showing signs of thermal leakage and upon visual and physical inspection leakage detected.

- Emergency exits show minor leakage (frequent manual use)

In ESB, Thermal flaws appeared at the emergency exits, which 40.5% of respondents reported using it more frequently. These areas also matched locations where half of the participants reported discomfort.

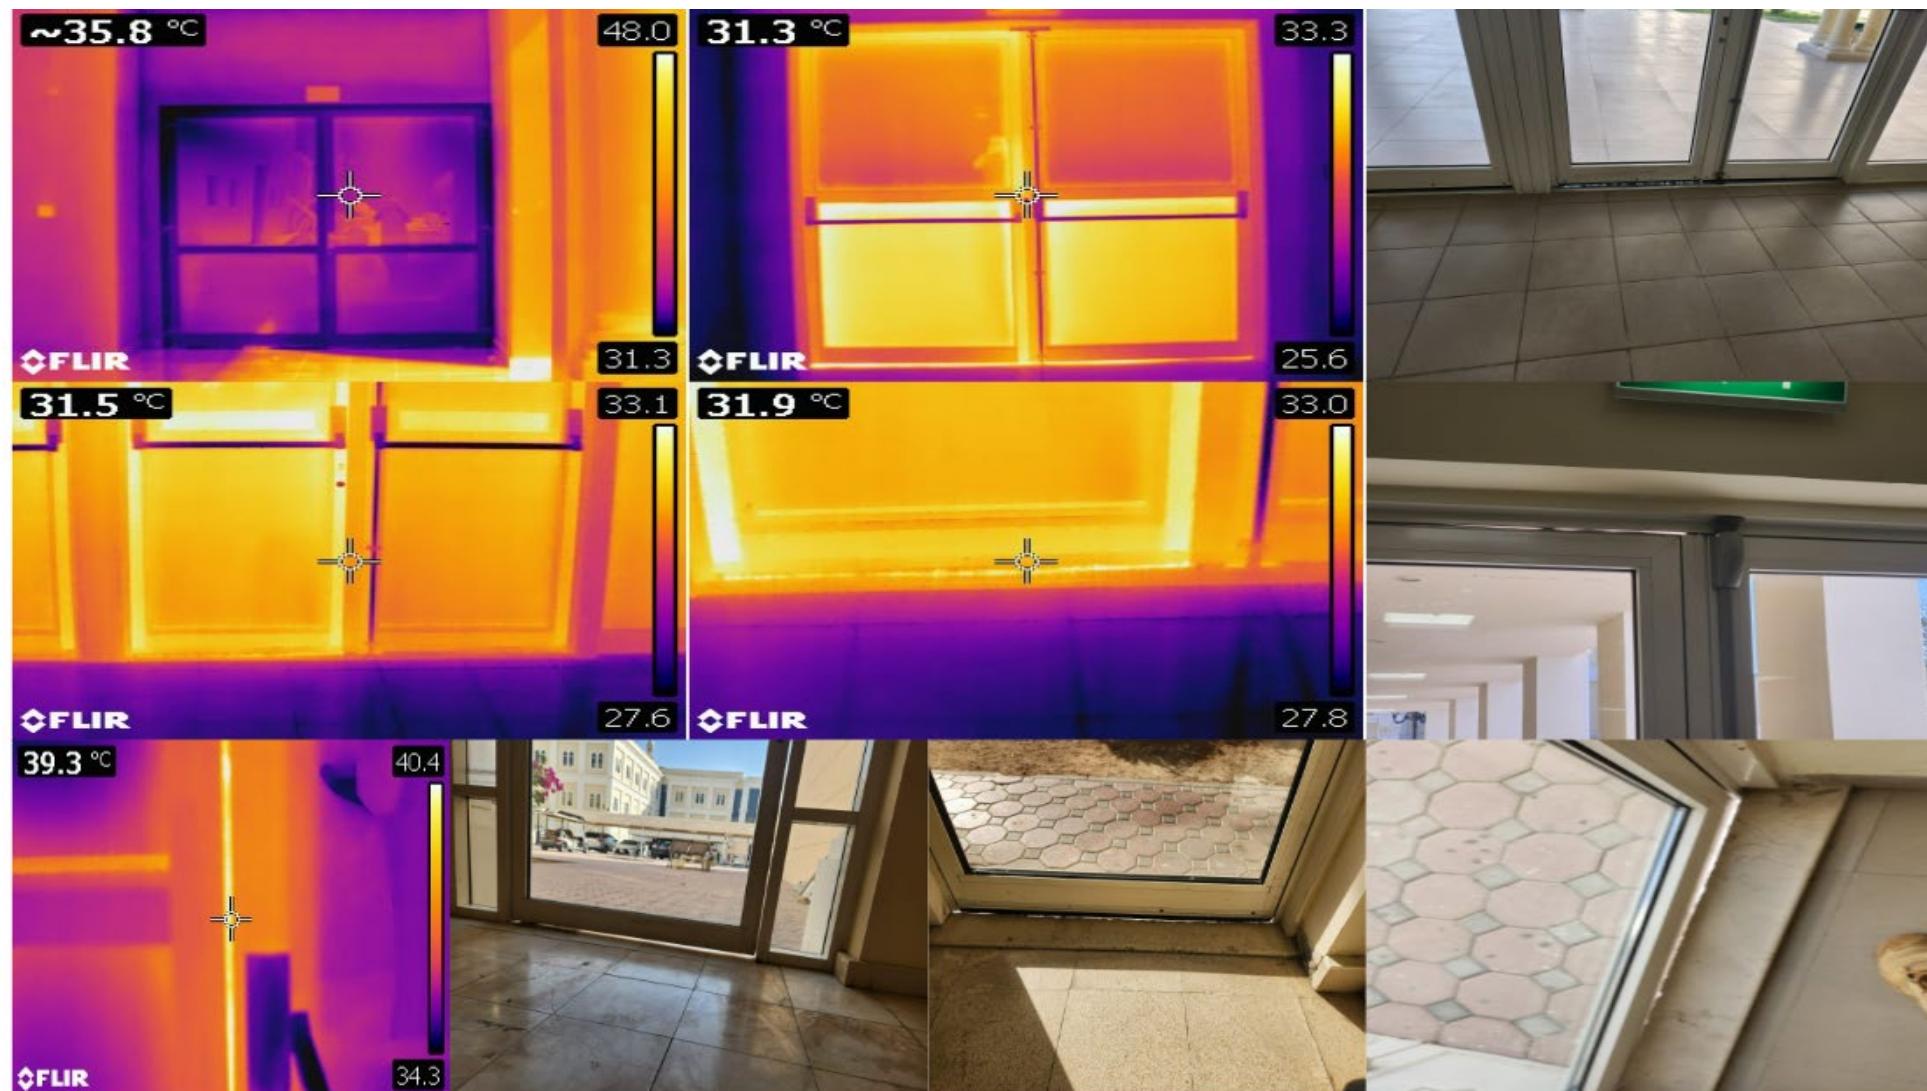
Main Entrance Doors & Emergency Exit Doors

Figure 5 : IR images and normal images capturing the main entrance and emergency exit doors of EB2 building showing signs of thermal leakage and visual inspection confirmed leakage on several doors.

- Widespread leakage at all doors (Main & Emergency Exit doors)

In EB2, widespread leakage at main and exit doors, Survey results reflected this, with lower comfort rates only 42.9% of users feeling comfortable and a larger portion reporting neutral or uncomfortable conditions.
