Landslide Definition by an Integrated Monitoring System

Landslides are one of the major types of natural hazards being responsible for great infrastructure damage world-wide, endangering thousands of people every year. In this paper, the case study of a big embankment of Egnatia Odos Highway in Northern Greece, founded on a landslide area, is examined by the means of an Integrated Monitoring System. The major goal is to define the exact area of the landslide, describe the characteristics of the movement (displacement/deformation) and determine the environmental causes that contribute to the phenomenon. The system consists of a combination of geotechnical instruments and a geodetic high precision monitoring system. The geotechnical instruments consist of deep inclinometers, piezometers and tiltmeters, which provide data of the sub-surface displacements and surface tilt deformations along with piezometric data.

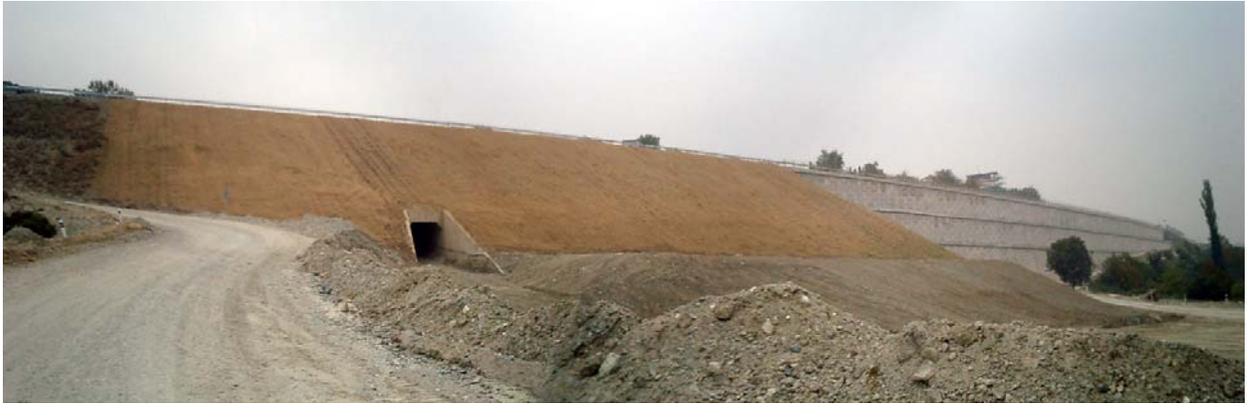
Figure 1: Asomata Case Study

The case study is an embankment of 25 m height and 150 m long. Approximately 50m of it is constructed with reinforced soil on one side (Figure 1.)

The monitoring system consists of 15 inclinometers, 4 piezometers, 3 survey monuments placed in the landslide area, 18 targets placed on the shoulder, 3 fixed survey monuments and 12 tiltplates placed on the reinforced soil. The place of the instruments is shown on Figure 1.

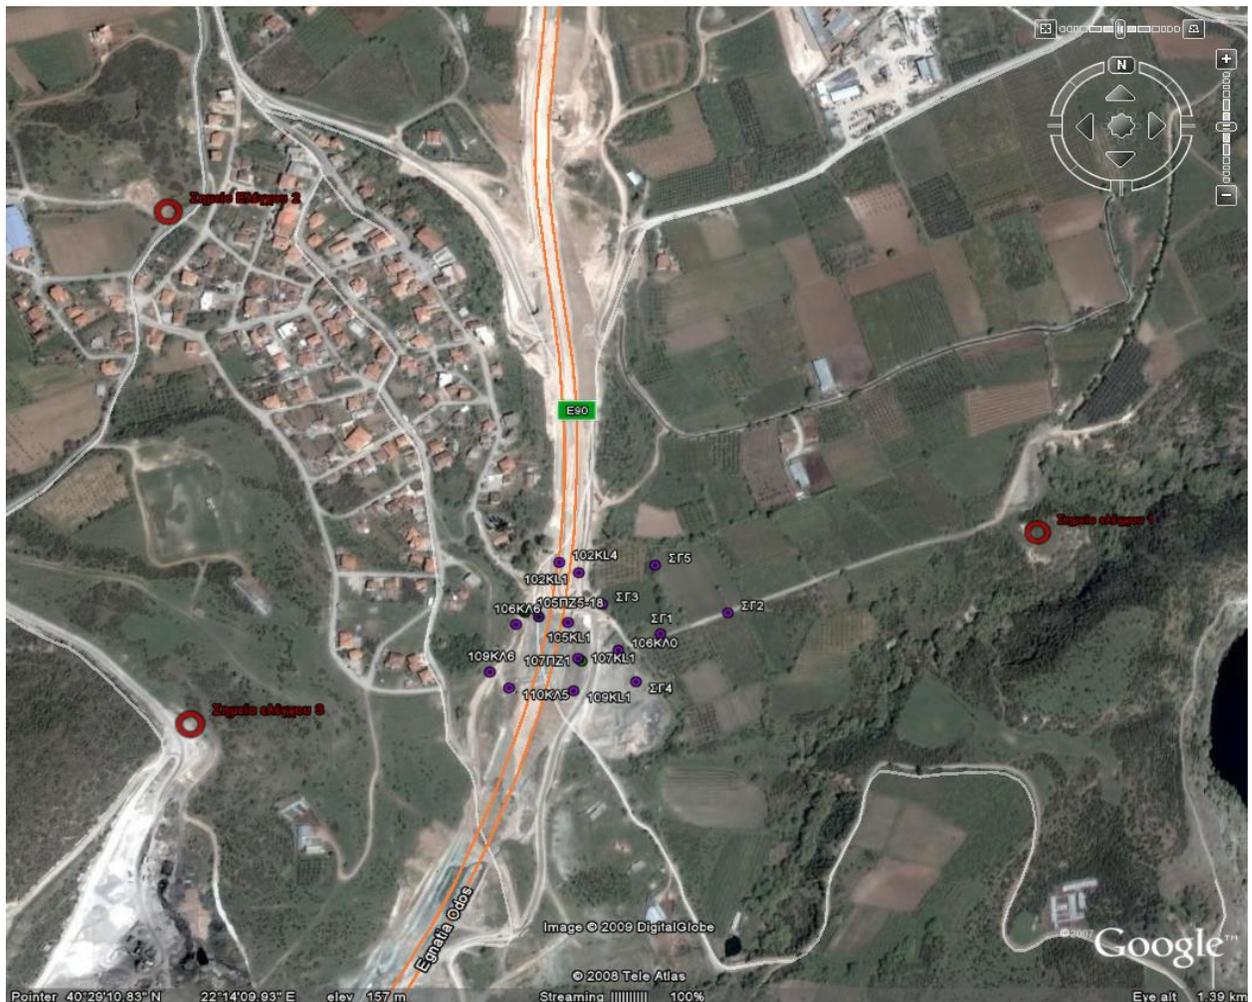
Figure 2: Monitoring Area, GPS Reference Network, Instruments Positions

The survey is designed to achieve displacement measurements of high accuracy. The methodology is based on a repeatedly observed local geodetic control network with the use of the Global Positioning System (GPS) and motorized highly accurate Total Positioning Station (TPS). A geodetic control network is established consisting of three reference stations (T1, T2, T3), which define a stable reference frame and three monitoring stations (M6, M7, M8) located in the landslide area.

The reference stations and the monuments along with the geotechnical instrument positions are shown in Figure 2.
